March 30, 2004

**Errata Document for CY7C637xx / enCoRe™ USB Combination Low-speed USB & PS/2 Peripheral Controller**

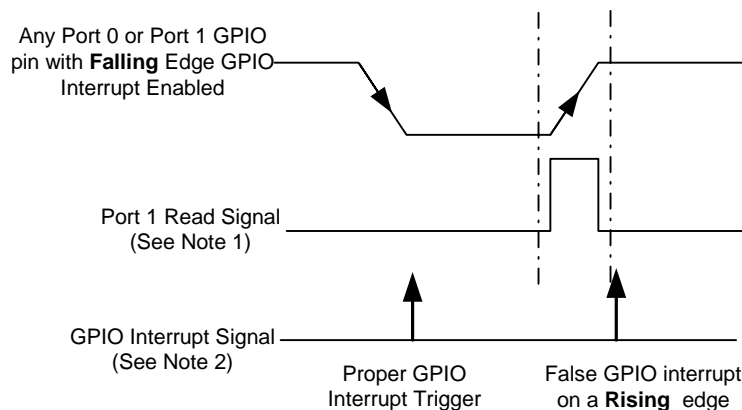
When a falling edge interrupt is enabled for a GPIO pin, reading the GPIO Port 1 coincident to a rising edge of that GPIO signal may generate a false GPIO interrupt.

Workarounds will need to be tailored to individual applications based on the flexibility of changing the GPIO usage, the timing of the GPIO interrupt sources and firmware interrupt latencies.

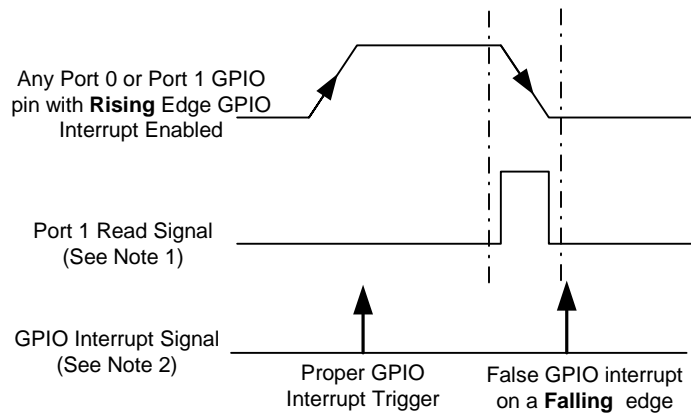
When a rising edge interrupt is enabled for a GPIO pin, reading the GPIO Port 1 coincident to a falling edge of that GPIO signal may generated a false GPIO interrupt
