KSZ8041 Silicon Errata and Data Sheet Clarification

This document describes known silicon errata for the KSZ8041 family of devices, which includes the following:

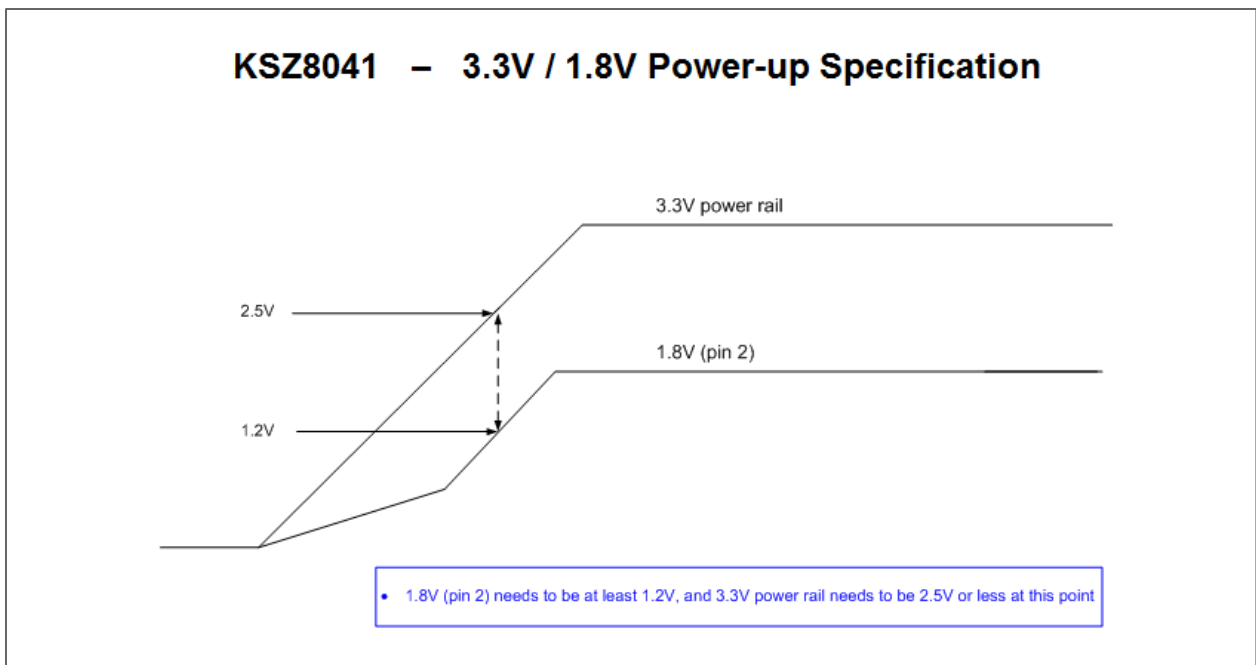
A small percentage (<1%) of devices can potentially encounter pin strapping failures with fast 3.3V supply rise times (<150us) or slow core rail rise times, due to a large bulk storage capacitor value (10uF or greater) for the 1.8V core.

When this errata occurs, pin strap values may not be correctly latched.

Reduce the 1.8V core bulk storage capacitor from 10uF to 1.0uF and ensure the 3.3V supply rise time is 250us or greater.
