# PIC18F87J50 FAMILY

## PIC18F87J50 Family Silicon Errata and Data Sheet Clarification

The PIC18F87J50 family devices that you have received conform functionally to the current Device Data Sheet (DS39775B), except for the anomalies described in this document.

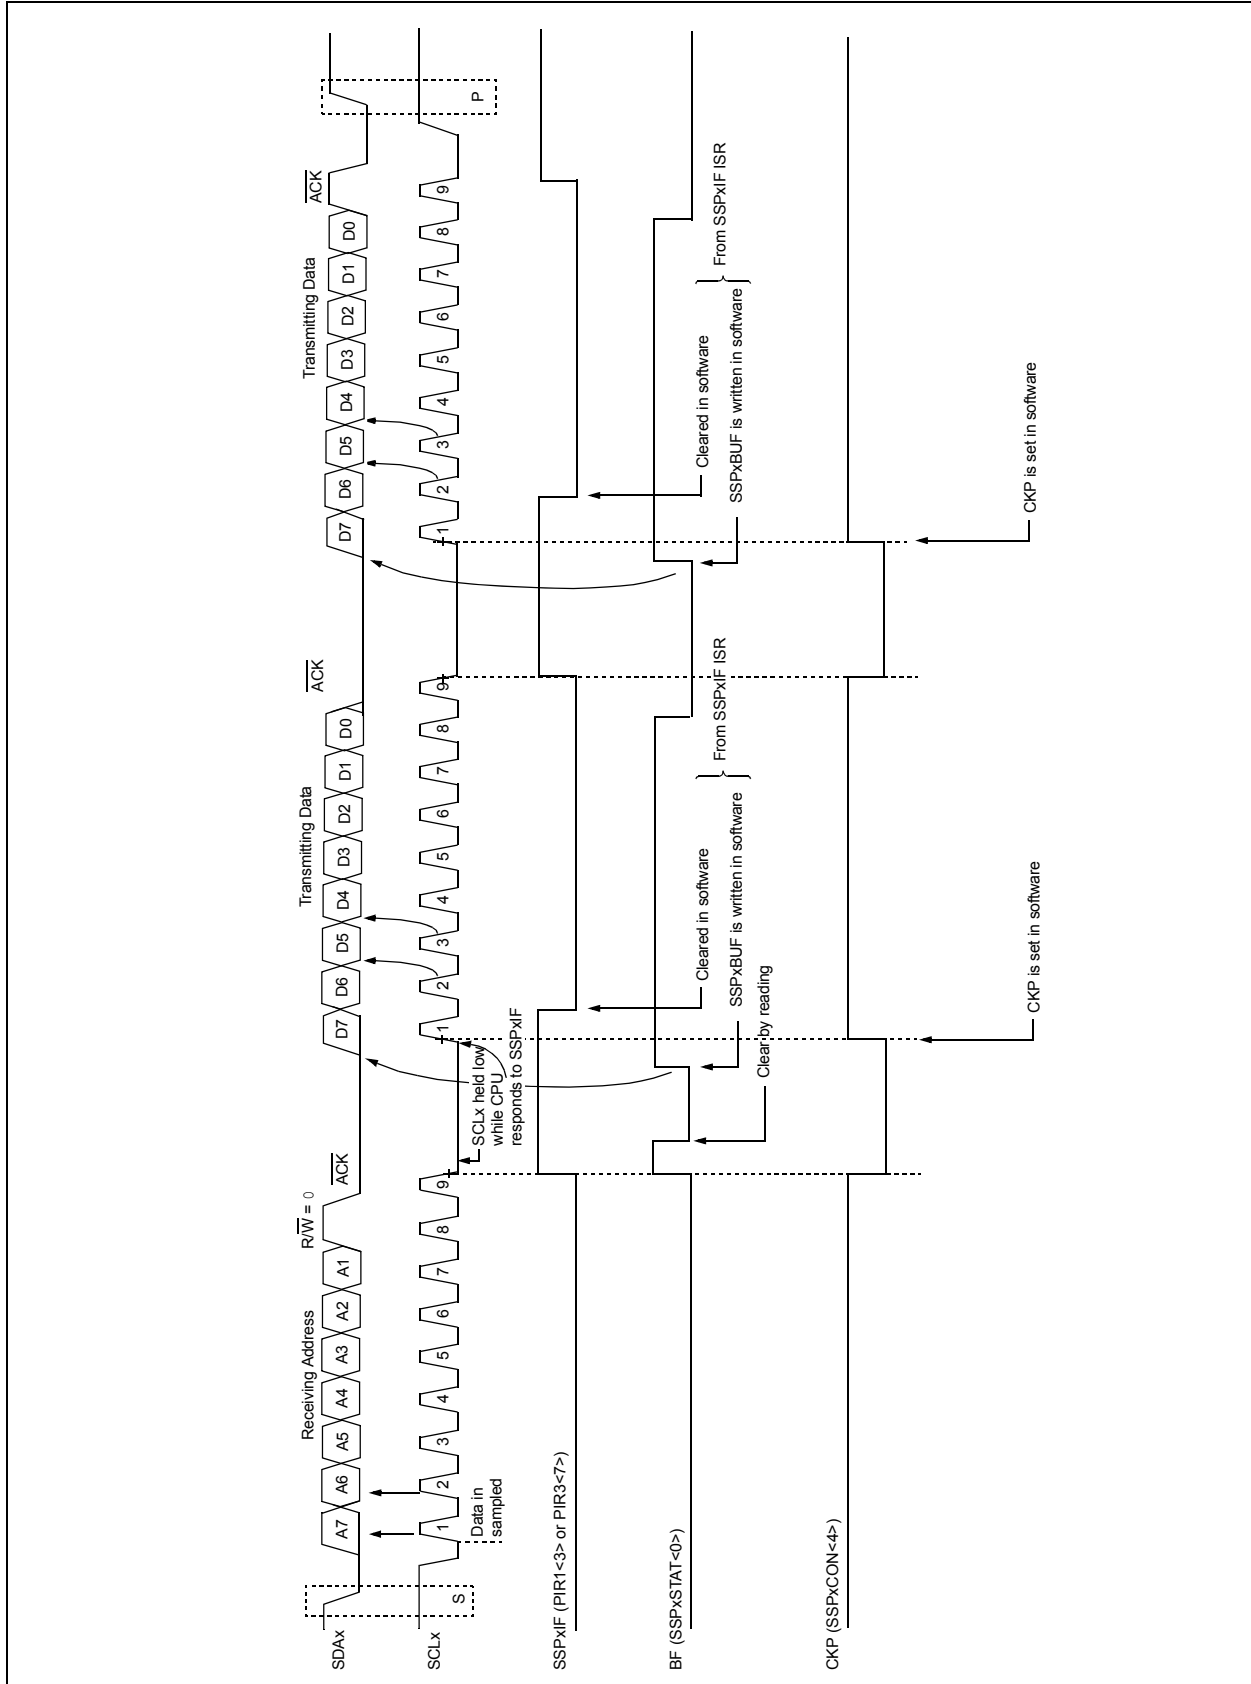
FIGURE 19-10: I<sup>2</sup>C™ SLAVE MODE TIMING (TRANSMISSION, 7-BIT ADDRESS)

## 6. Module: Figure 19-10: I<sup>2</sup>C™ Slave Mode Timing (Transmission, 7-Bit Address)

On page 252, the figure is replaced with the new timing diagram provided in Figure 19-10.

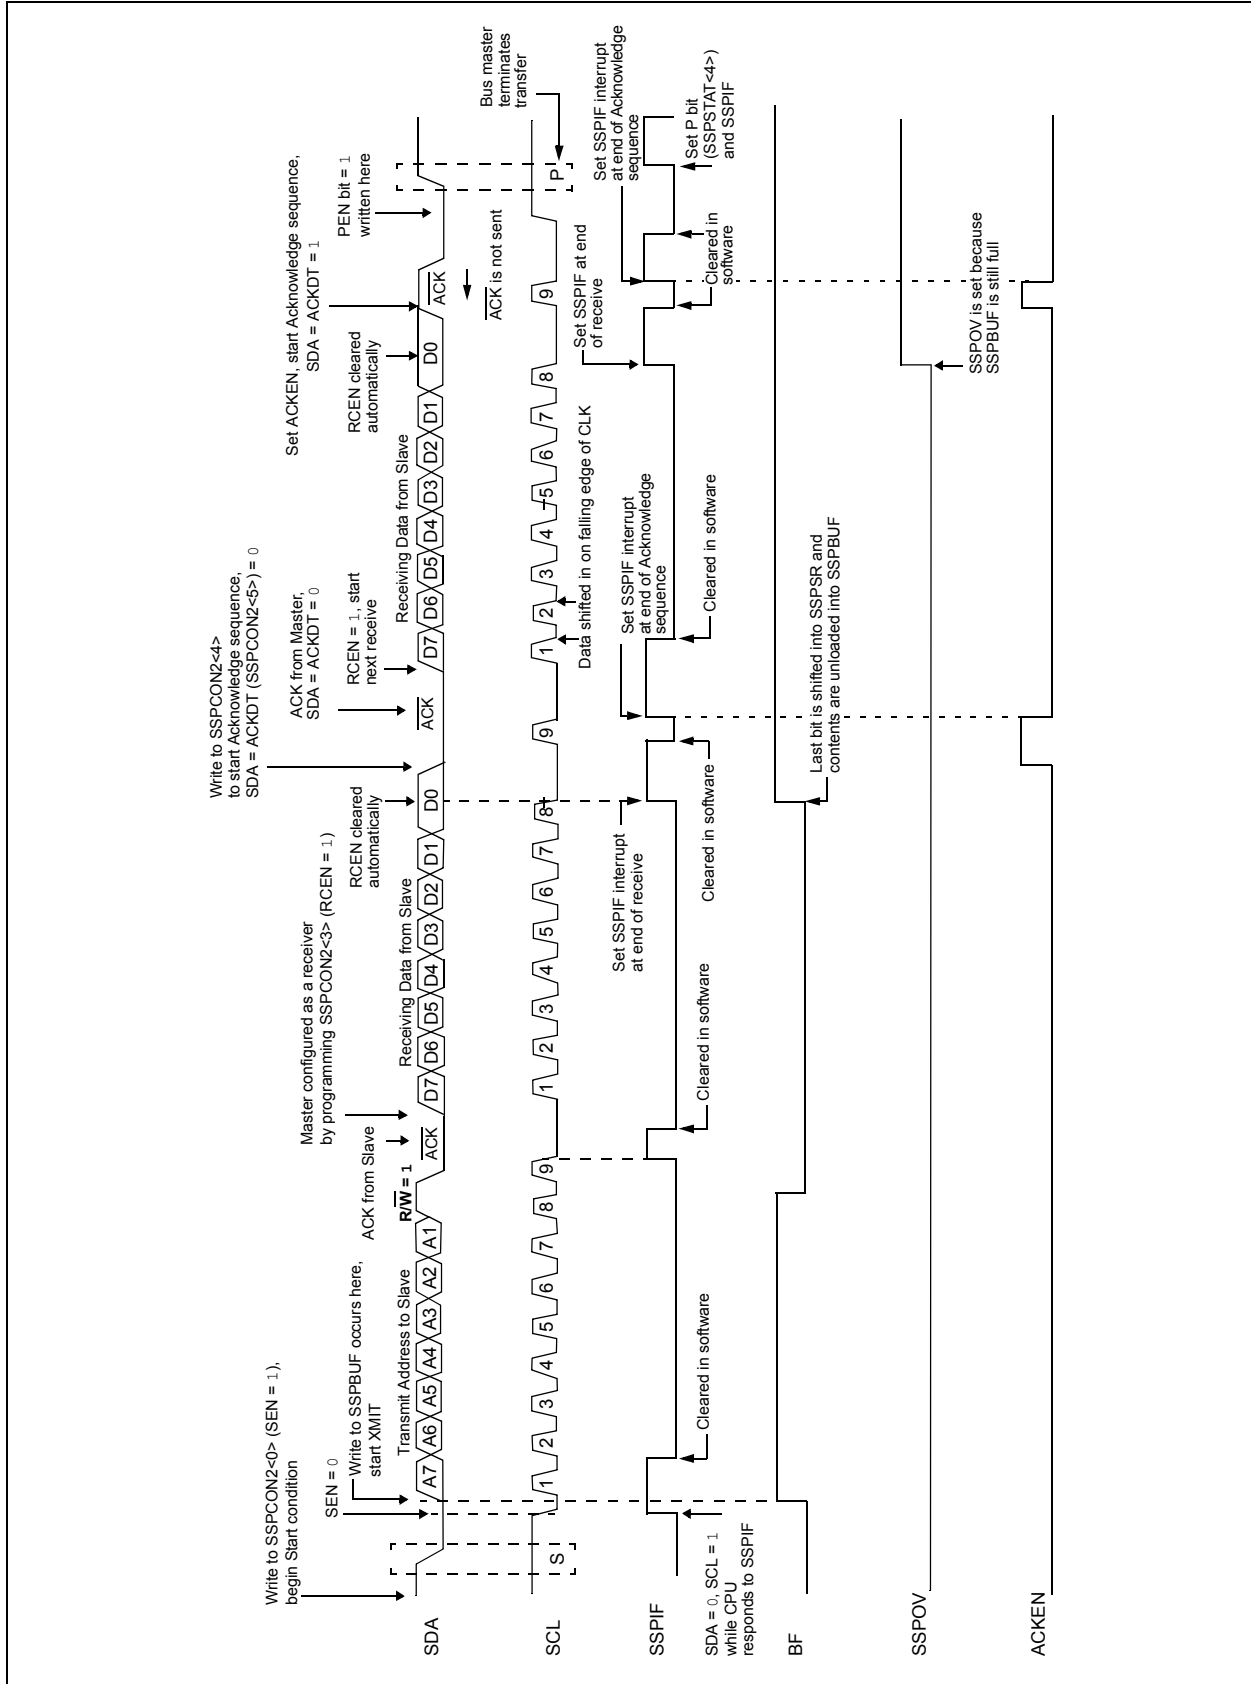
**FIGURE 19-24: I<sup>2</sup>C™ MASTER MODE WAVEFORM (RECEPTION, 7-BIT ADDRESS)**

## 7. Module: **Figure 19-24: I<sup>2</sup>C™ Master Mode Waveform (Reception, 7-Bit Address)**

On page 269, the condition,  $R/\overline{W}$ , when the Acknowledge signal (ACK) is received from the slave, after transmitting the address to the slave, is changed to '1'.

The changed value is indicated in bold text in Figure 19-24.
